Evaluation Report

George White Model SW480 Field Sprayer

ALBERTA
FARM
MACHINERY
RESEARCH
CENTRE

GEORGE WHITE MODEL SW480 FIELD SPRAYER

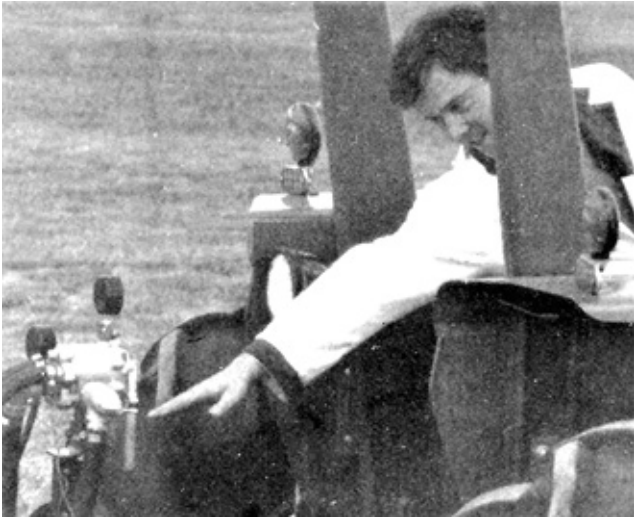
The pressure gauges were easily read from the tractor seat. The pressure regulator and boom control were inconvenient to reach from the tractor seat (FIGURE 15) while the agitator control valve could not be reached. Relocation of these controls so that they could be conveniently adjusted from the tractor seat would be desirable. The tank liquid level indicator was easy to read when the sprayer was new or if the solution in the tank was opaque. With clear solution such as Banvel, the white ball float was difficult to see after the gauge line clouded with chemical. The gauge gave only a rough indication of fluid level since operation on hills and movement of liquid in the tank caused the indicator reading to fluctuate.

FIGURE 15. Controls Difficult to Reach from Tractor Seat.

2. Modifications to permit convenient adjustment of controls from the tractor seat.
3. Relocating the line strainer to prevent chemical from spashing on the operator's hands.

1. Better quality oil filled pressure gauges are now supplied with production models of this sprayer. Future units will be metric.
2. Modifications of the control post are under consideration for 1979 production.

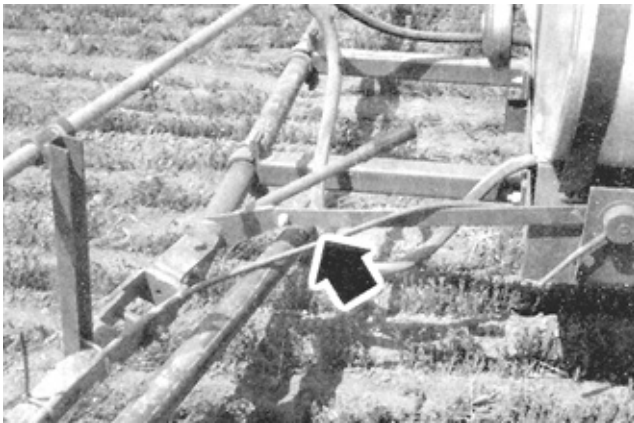
Transport: The George White SW480 could be folded into transport or placed into field position in about five minutes. There was interference between the right radius brace and the boom adjusting linkage (FIGURE 16) unless the brace was unfolded before placing the boom to field position. This was awkward in soft fields where the booms were hard to move.

FIGURE 16. Interference Between Radius Brace and Boom Adjusting Linkage.

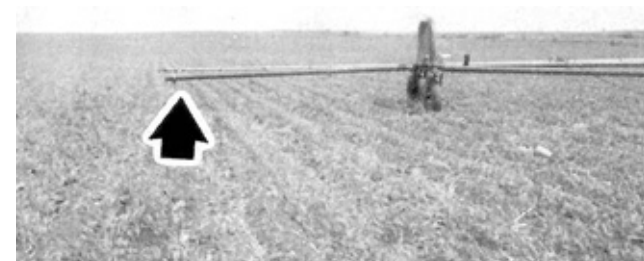
- It was leaking and tightened again at	33	621	(1536)
- It was leaking and repaired with teflon tape at	69	1299	(3211)
- The ends of the booms were sagging at	50	942	(2327)

Boom vibration at the outer ends of the 64 mm (2.5 in) boom support rails caused a 50 mm (2 in) sag after 50 hours of operation (FIGURE 19).

FIGURE 19. Sagging Boom End.

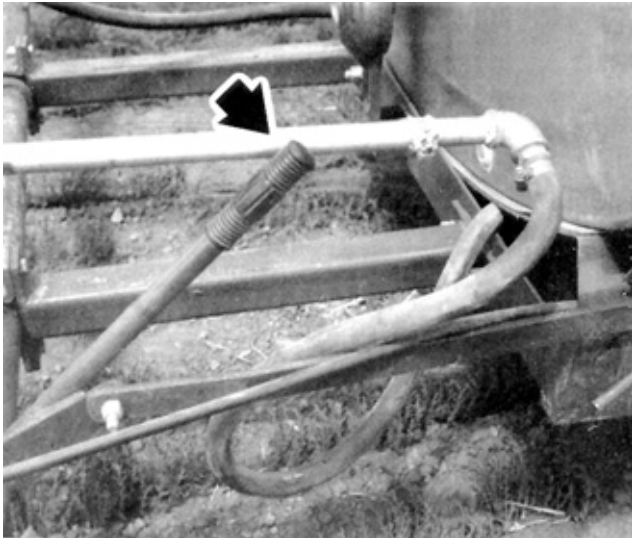
Boom Transport Interference: Interference between the right boom and the boom adjusting handle (FIGURE 20) caused the right boom to bend when turning in transport. Interference was eliminated

FIGURE 20. Interference Between Boom Adjusting Handle and Right Boom in Transport.

12. Modifications to eliminate leaking at the threaded boom pipe couplers.
13. Modifications to eliminate boom damage caused by boom interference in transport.
14. Modifications to prevent bending of the hitch pin clips on the transport tie bar.

12. A hose coupling will be featured on 1979 production models.
13. The boom handle has been modified to eliminate this problem.
14. Hitch pin clips will be replaced with snap pins on 1979 production booms.

The basic configuration of the 64 and 76 mm (2.5 and 3 in) boom support rail assemblies were the same so the same interference problems were encountered with the 76 mm (3 in) assembly. Modifications are required to prevent boom damage caused by interference in transport.
